CHALK STREAMS AND WETLAND MEADOWS
RIVER RESTROATION PROJECTS
CASE STUDY: HAMBLE BROOK

CHILTERN'S
CHALK STREAMS
PROJECT

January 2024

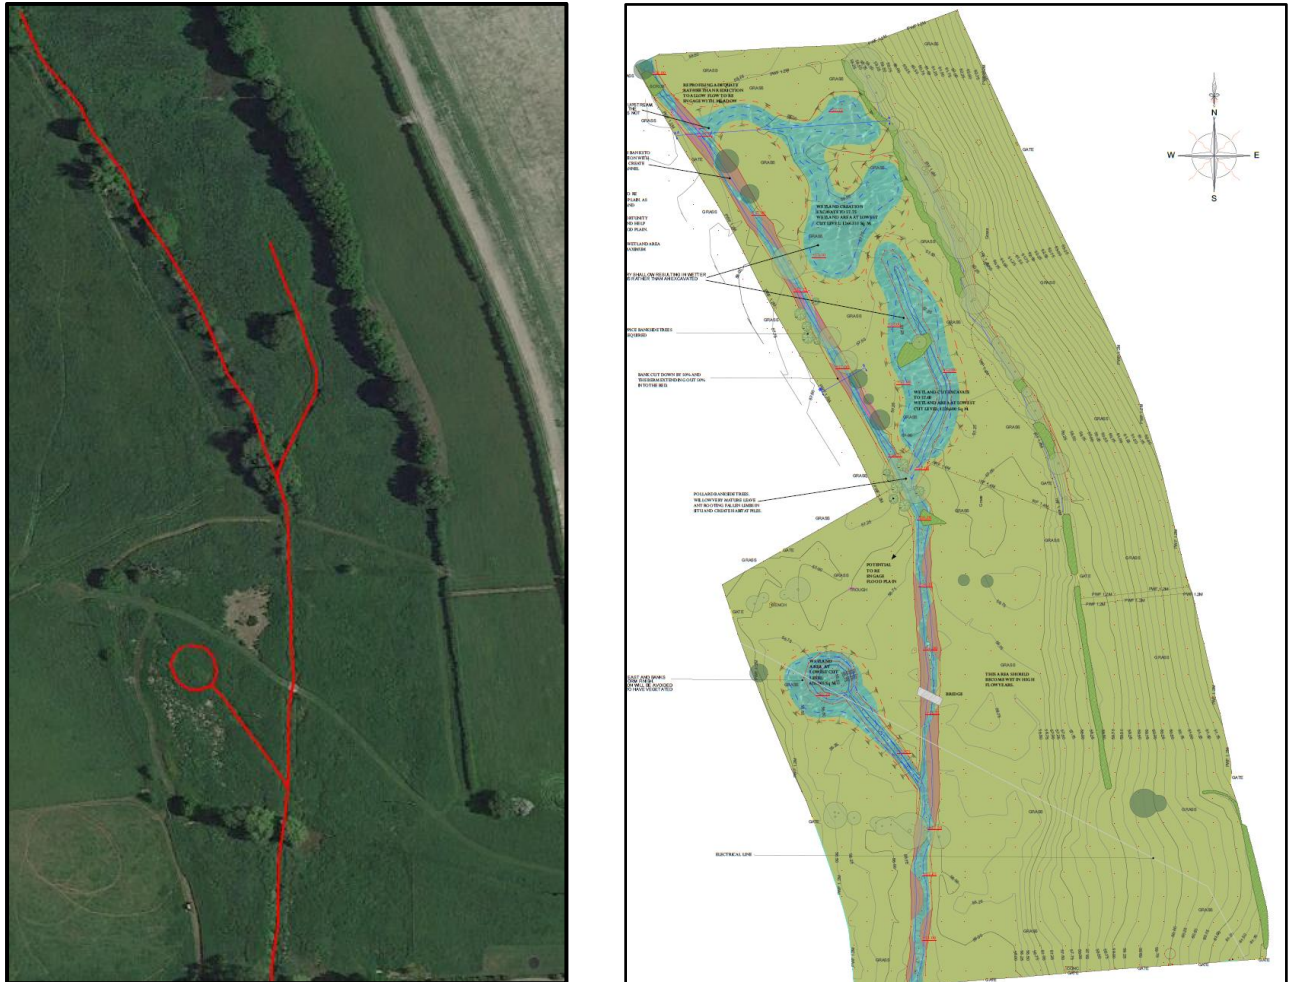
Figure 3: Comparison between existing & proposed landscapes showing the positive benefits brought by the project

The plan was to re-naturalise all these areas by increasing the hydromorphological variation and improve the connectivity with the adjacent landscape through:

- Using cut & fill techniques to reintroduce sinuosity to the channel,
- Create a narrow first-stage channel in the river bed that encourages sediment mobilisation during low flow times and includes pools and riffles,
- Create shallow sloping berms that encourage the growth of marginal vegetation,
- Introduce two backwaters within the existing swimming sites,
- Soften the gradient of the bank and where practicable, remove previously dredged material from the bank tops,
- Sculpt the two ponds to create a variety of water depths and slope gradients,
- Replace one bridge to improve fish passage and reduce flow impoundment,
- Lower the bank top at strategic sites to promote the flow of water from the channel into the adjacent landscape during high flow periods,

Works to deliver the two wetland areas in Reach 1 (see Fig. 3 above) were carried out in November 2023 using a single long arm excavator and Hydrema 912 compact dump truck. The design focussed on the naturally lower, wetter areas as indicated by a ground survey completed previously as well as the vegetation types. the top-soil & vegetation layer was removed and set aside before digging out a flat bottomed bed with gentle slopes and rounded edges. Removed material was sculpted into a shallow slope running parallel to the eastern field boundary which has the effect of softening the existing bank face, before the set aside top-soil and

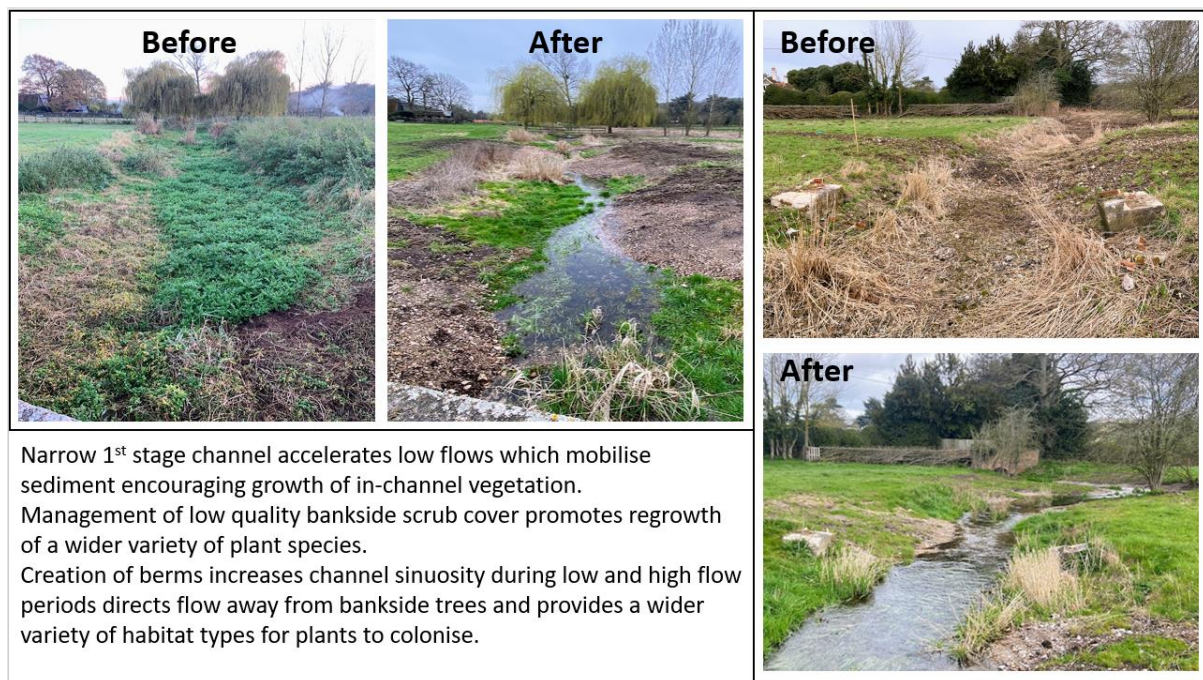
Figure 5: Hamble Brook channel restoration comparison

Channel improvement has been completed in accordance with the list above, resulting in restoration of 16% of the entire length of the Brook, which is the largest project of its type ever attempted according to the Environment Agency.

Fencing along the right bank of Reach 1 is 8m back from the channel and all other fencing proximal to the channel has been removed.

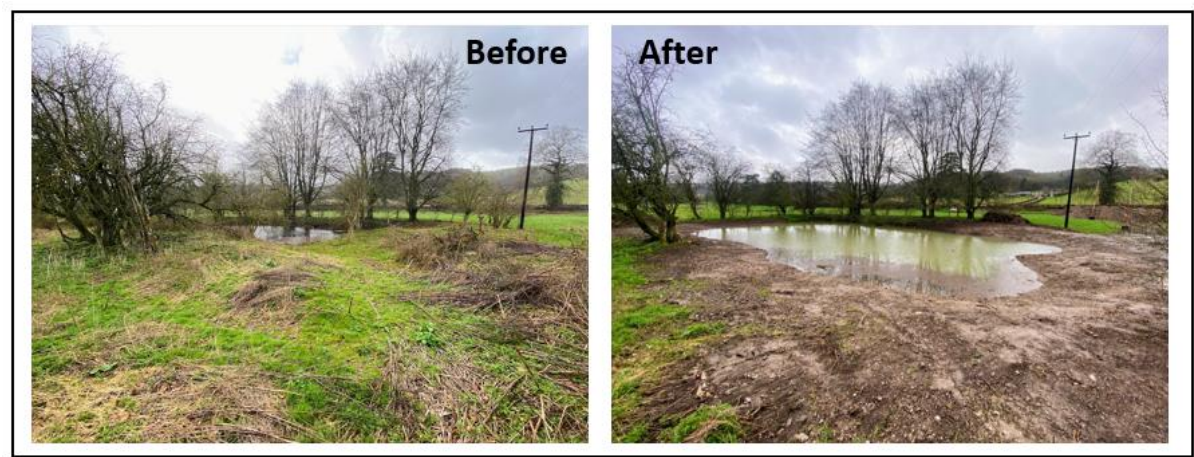
Figure 7: Hamble Brook pond restoration comparison

Improvement works to ponds, spring and associated channel has been completed to include softer bank gradients and a more natural form and variety of depths, to support different plant and animal species.

Management of bankside tree and scrub cover improves tree health and promotes regrowth of a wider variety of plant species.
Enlargement provides greater volume of water for pond durability and overall temperature stability.
Increased variation in bank slope gradient and introduction of shelves at different depths increases variety of habitats for plants, insects and animals.
Hibernaculum created from scrub materials provides shelter for macroinvertebrates, toads and other creatures.

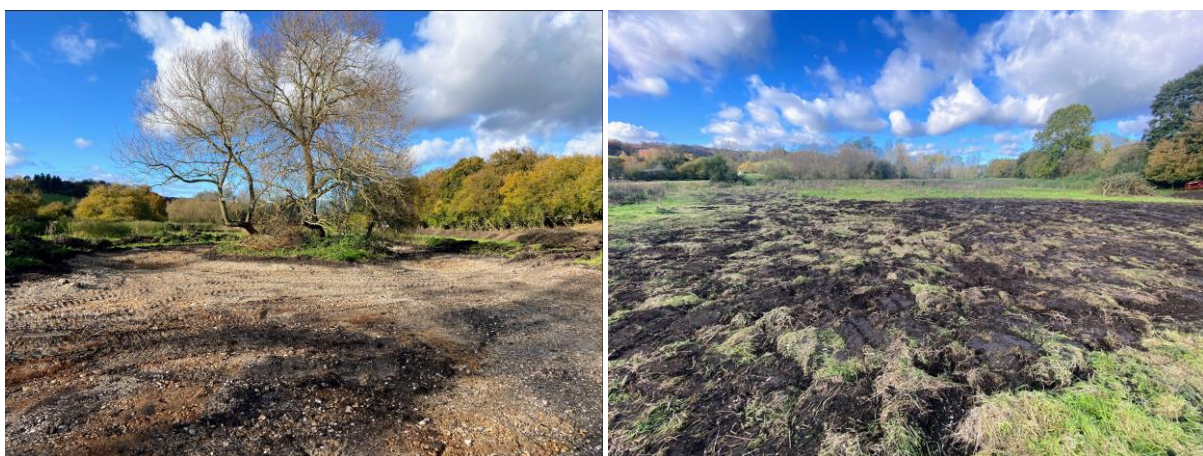
Figure 9 - Reach 1 wetland (left) during construction and (right) with top soil replaced - November '23

vegetation layer was returned to provide a seed-bank for recovery as well as restoring a more natural appearance to the ground cover.

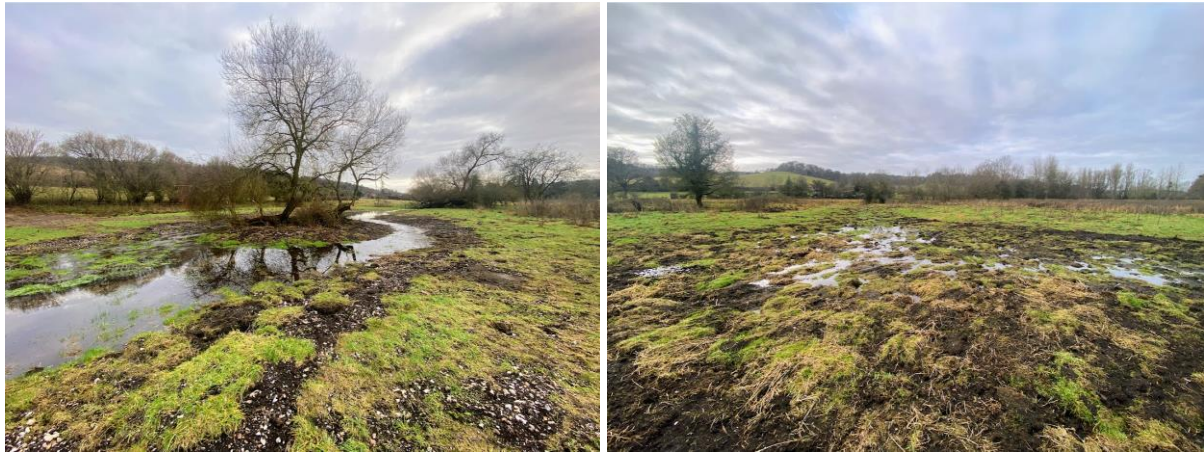
Figure 10 - The new wetland area filling as the ground water rises - December '23

Being a winterbourne valley with a large annual fluctuation in ground water levels, the wetland areas will not be wet all the time, but being closer to the water table they will be wetter earlier and for longer. And the design is such that they can also be fed, or topped-up by a spring channel as well as, during high flows, the main river.

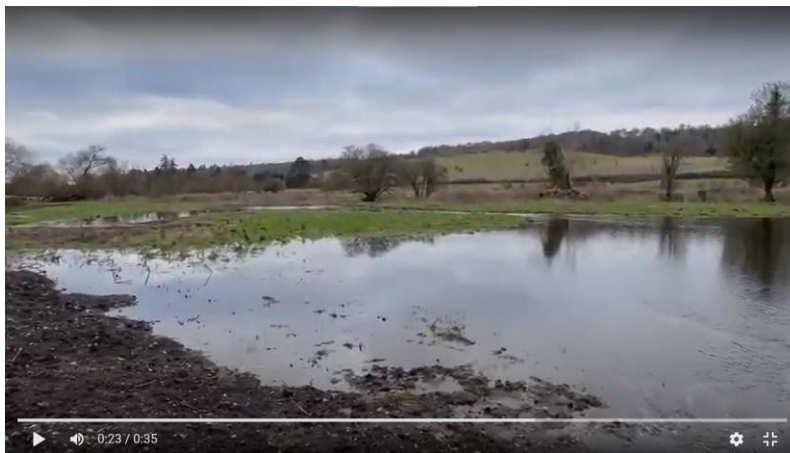
Figure 11 - Video still showing water flowing through wetland area in high ground water during January '24. Note: Main channel is NOT visible in this image. © Maria Spink

During the winter of 2023-2024 the ground water was exceptionally high; recorded on 23rd November as being 2.7m higher than the same date in the previous year. This filled the wetland areas entirely and created flow paths that approximated paleochannel flows through the same area.

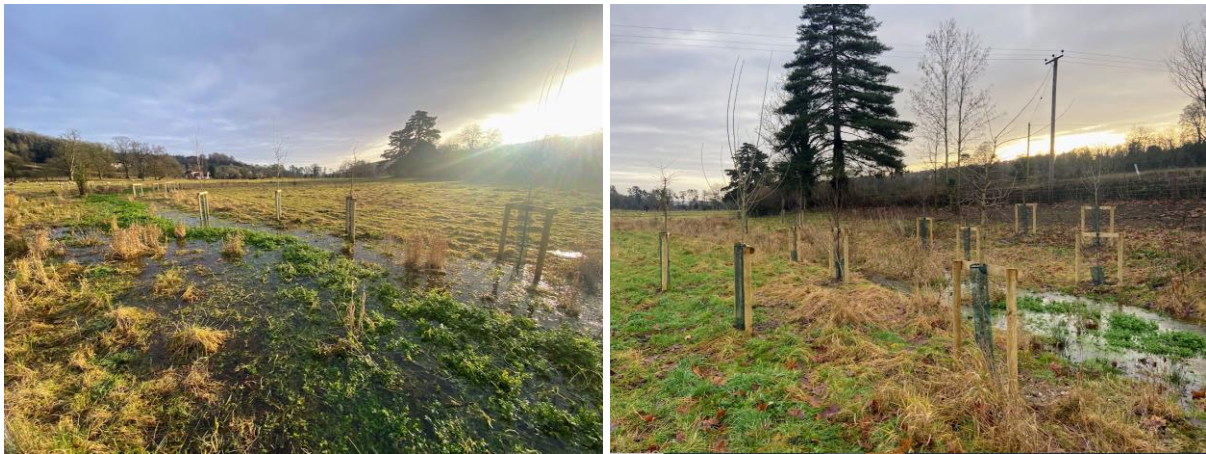
Figure 12 – Some of the recently planted native saplings that will provide shade, habitat and temperature control

By planting larger trees, of 8 to 12cm trunk girth, we will gain some immediate benefit in channel shade which will only increase as the trees mature.

Each tree is supported by two posts connected by a cross-member support and the trunk surrounded by an expandable mesh fence that will protect against grazing damage from sheep and deer up to a height of 1.8m. The landowners have the option of installing more robust anti-grazing protection.
